Inspection

Sample Report, QWE 123

Date of Report	24/11/2025
Reference No	10071709
Type of Property	House Detached
Landlord	Mr Smith
Tenants Name	Mr Bond
Tenant Present	YES
Prepared By	Mr Jones

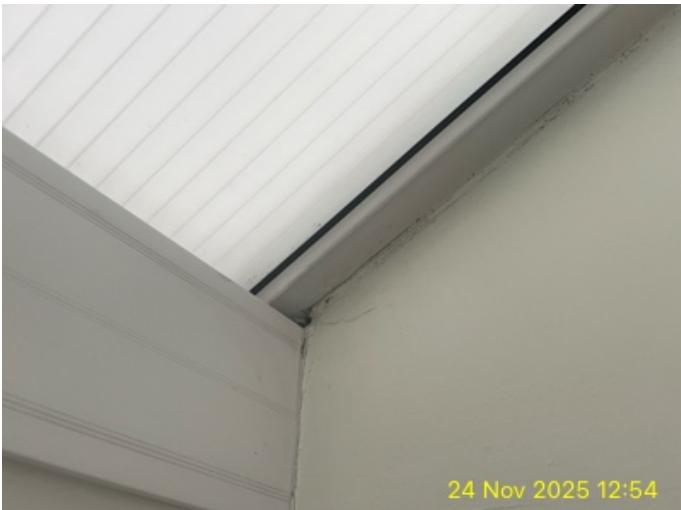
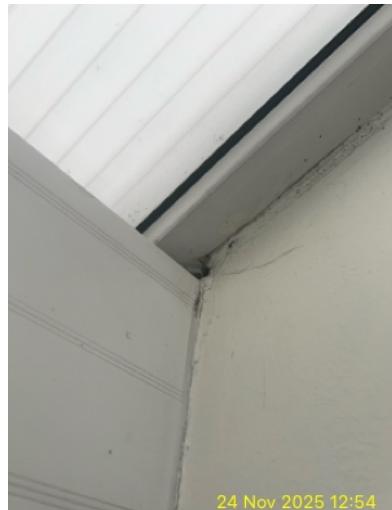
REF 2

Ref	Item Name	Excellent	Good	Fair	Poor	Comments
1	Hallway		✓			Overall well maintained, no visible signs of damage
2	Dining Room		✓			The tenant has reported cracks to the wall and cornice. The landlord should be notified and contractor instructed to repair.
3	Lounge	✓				Overall well maintained, no visible signs of damage
4	Kitchen		✓			Good condition no visible issues. Appliances not tested.
15	Conservatory					Good condition. No visible issues.
16	Bedroom 1	✓				Clean and tidy. No visible issues.
8	Bathroom				✓	The tenant has reported a leak from the shower head. Which has caused damage to the ceiling.

Notify the landlord of the maintenance issues listed in this report.

Instruct contractor to attend to my noted comments.
